## CLINICAL IMAGES

## Tremor mimicking ventricular tachycardia

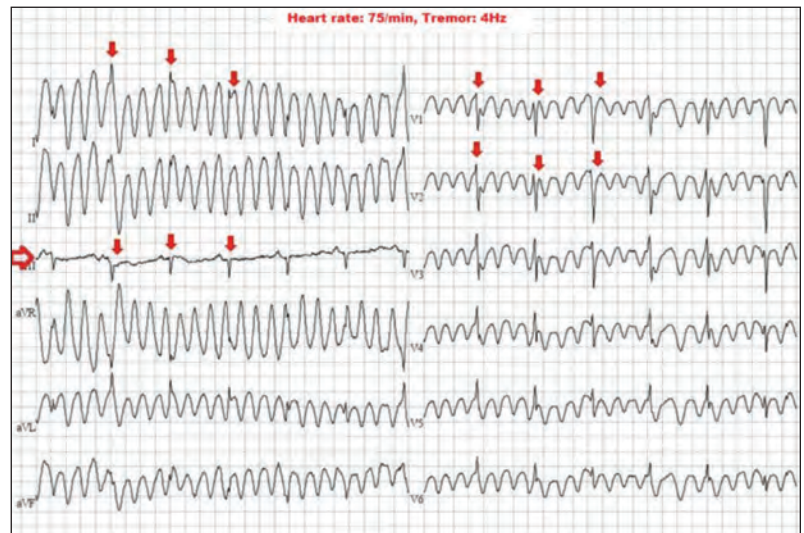
**Figure 1:** Electrocardiogram showing a tremor (4 Hz) causing an electrocardiographic artifact. Normal QRS complexes can be seen interspersed between artifact waves (small arrows). A normal sinus rhythm is seen in frontal lead III (large arrow). The amplitude of the registered tremor is more pronounced in the tracings from the frontal leads than in those from the precordial leads.

Tremor can cause ECG artifacts that mimic a broad QRS complex tachycardia.<sup>1</sup> Characteristics allowing differentiation from a broad QRS complex tachycardia include the finding of normal QRS complexes between artifact waves (Figure 1, small arrows) or an unstable baseline at the beginning of the ECG recording (not shown). One of the upper extremities is often free of tremor, which results in a normal ECG tracing in one of the frontal leads (Figure 1, large arrow).<sup>2</sup> A simple bedside evaluation allows for the recognition of important clinical clues, such as a tremulous patient without hemodynamic compromise and detection of a normal pulse during palpitation or cardiac auscultation. Misdiagnosing artifacts as ventricular tachycardia may result in patients having to undergo a range of unnecessary diagnostic and therapeutic procedures, including electrophysiologic testing, anti-
