Appendix 2 (as submitted by the authors): Supplementary Figure 2

Appendix to: Dmytriw A, Alrashed A, Yang VXD. Posterior fossa dural arteriovenous fistula. *CMAJ* 2020. doi: 10.1503/cmaj.190920. Copyright © 2020 The Author(s) or their employer(s).

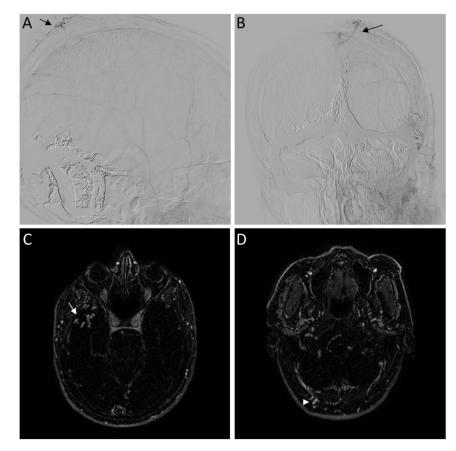
Repeat conventional and magnetic resonance (MR) angiography at 2-year follow-up showing collateral venous drainage and a new small nonaggressive dural arteriovenous fistula. (A) Anteroposterior and (B) lateral angiograms at 2-year follow-up showing the fistula in the region of the superior sagittal sinus (black arrow). (C–D) Axial MR angiography showing prominent collaterals in the right middle cranial fossa (white arrow) and right transverse sinus (white arrowhead) regions.
